# VILLAGE OF NORTH SYRACUSE

# Parks Master Plan

November 1, 2006

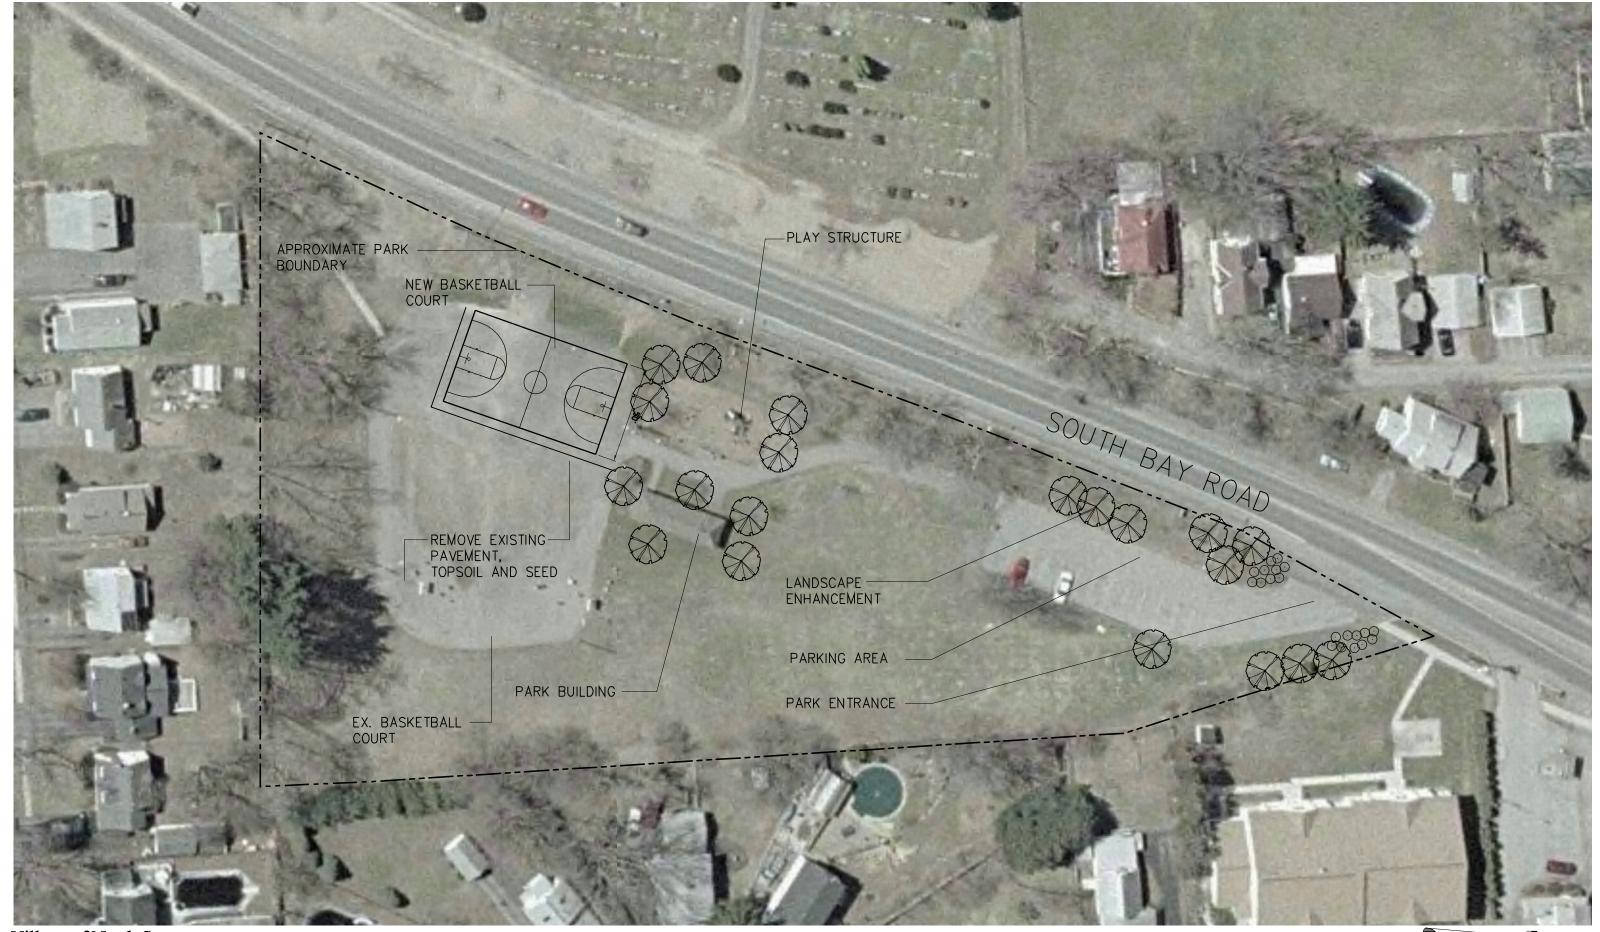
CENTERVILLE PARK

The park sign is in fair condition. The entry is lacking stop signs and the park entrance asphalt roadway surface is in poor condition.

The asphalt pavement and wood bollards are in poor condition. The 12 parking spaces appear to be adequate.

The asphalt surfaced basketball court is in fair condition but is lacking adequate drainage.

The two hoop systems are in poor condition. The storm drainage is poor; ponding water accumulates on the pavement.

The play structure is designed for 6-12 year olds and is in good condition. The safety surface (wood chips) under the play structure is not maintained and in poor

condition. The play structure area lacks perimeter edging to contain the safety surface. The play structure area lacks parent supervision zone or seating area.

Building is in poor condition and heavily vandalized. Access ramp to the structure is in poor condition and does meet ADA standards.

- 1. Resurface asphalt surface with new asphalt top course.
- 2. Replace wood bollards.

- 1. One alternate is just to remove this building.
- 2. Second alternate is to make the following improvements to the building: Remove all siding to become an open pavilion, thus reduce the vandalism threat. Add new ADA accessible entrance ramp.

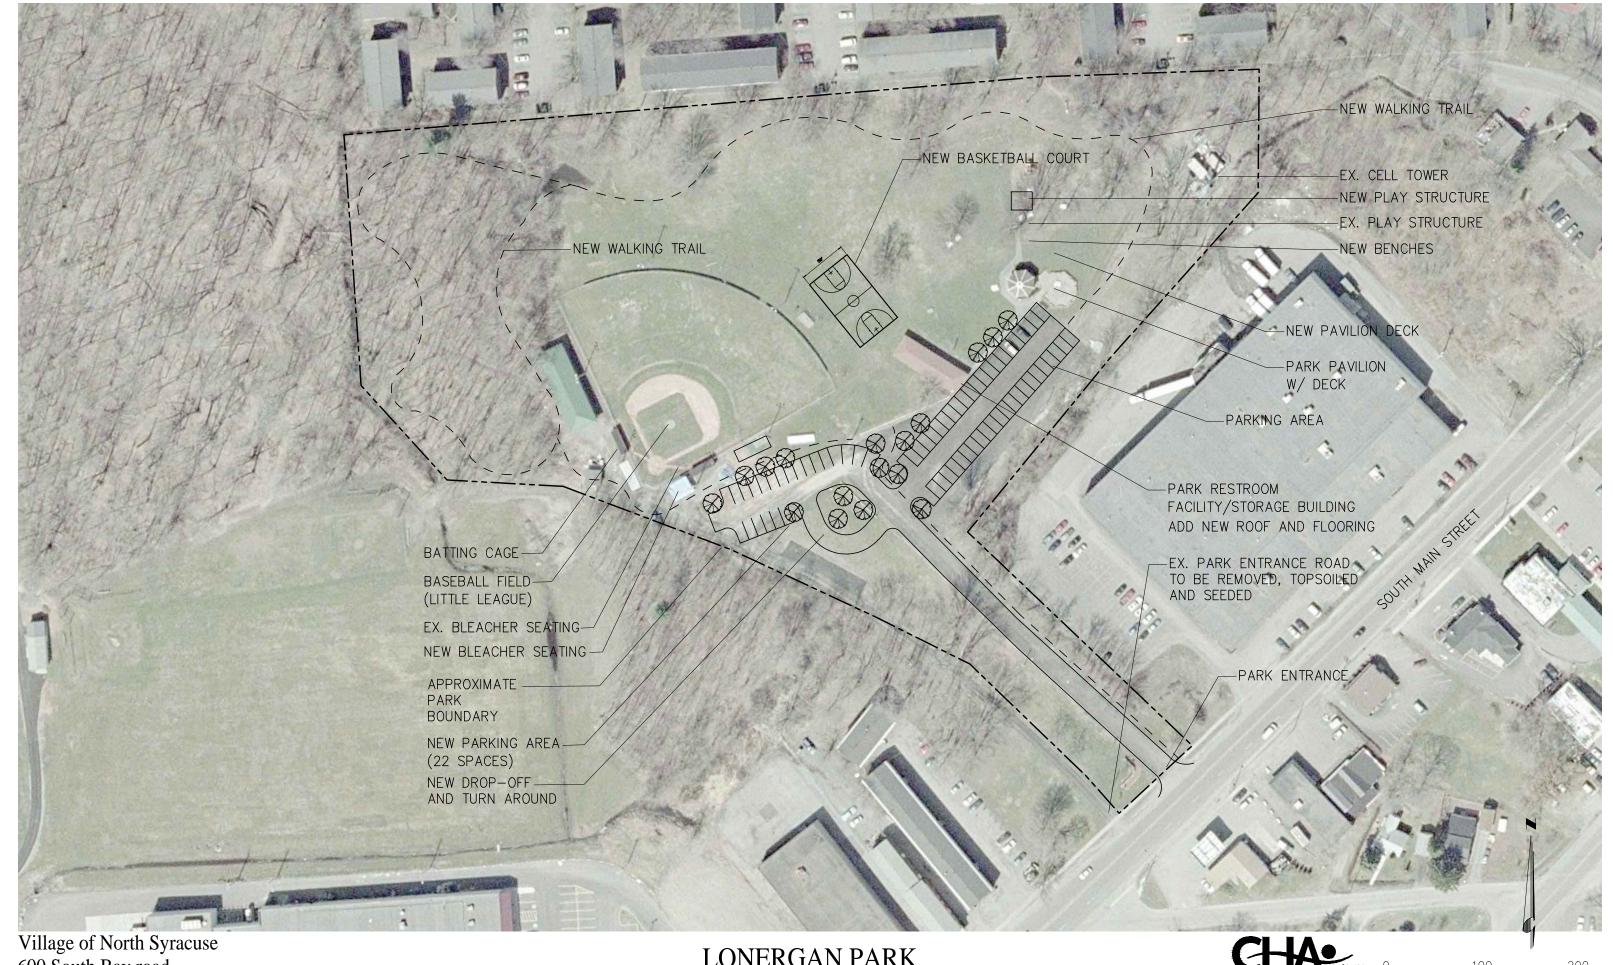
LONERGAN PARK

The park sign is in good condition. The park entrance asphalt roadway surface is also in good condition.

The asphalt pavement is in good condition but the wood perimeter bollards are in fair condition.

The little league field with batting cages, dugouts are in good condition. The small bleachers are in poor condition and should be replaced. The park is lacking other active uses such as basketball courts.

The picnic area is adequate in size but this area is lacking picnic tables. The play structure is designed for 6-12 year olds and is in good condition. The safety

surface (wood chips) under the play structure is not maintained and in poor condition. The play structure area lacks perimeter edging to contain the safety surface. The play structure area lacks parent supervision zone or seating area.

The building flooring and roof are in poor condition.

The pavilion is in good condition but the surrounding deck is in poor condition.
- Recommended improvements:
  - 1. Replace the pavilion deck.

- 1. Replace bleachers at the little league field.
- 2. Add two new basketball courts.
- 3. Add 10 benches throughout the park and 5 picnic tables at the picnic area.
- 4. Remove old play equipment such as jungle gym and swings.
- 4. Add perimeter edging around the play structure to contain the safety surface and add new safety surface.
- 5. Add a new play structure for younger children (age group of 2-5).

1. Replace the flooring and roof.
